**Environmental
Operations, Inc.**
CLEARING THE WAY

December 15, 2016

RE: Vapor Intrusion – Sub Slab Sampling
Solutia – John F. Queeny Plant
St. Louis, Missouri
EPA ID No. MOD 004 954 111

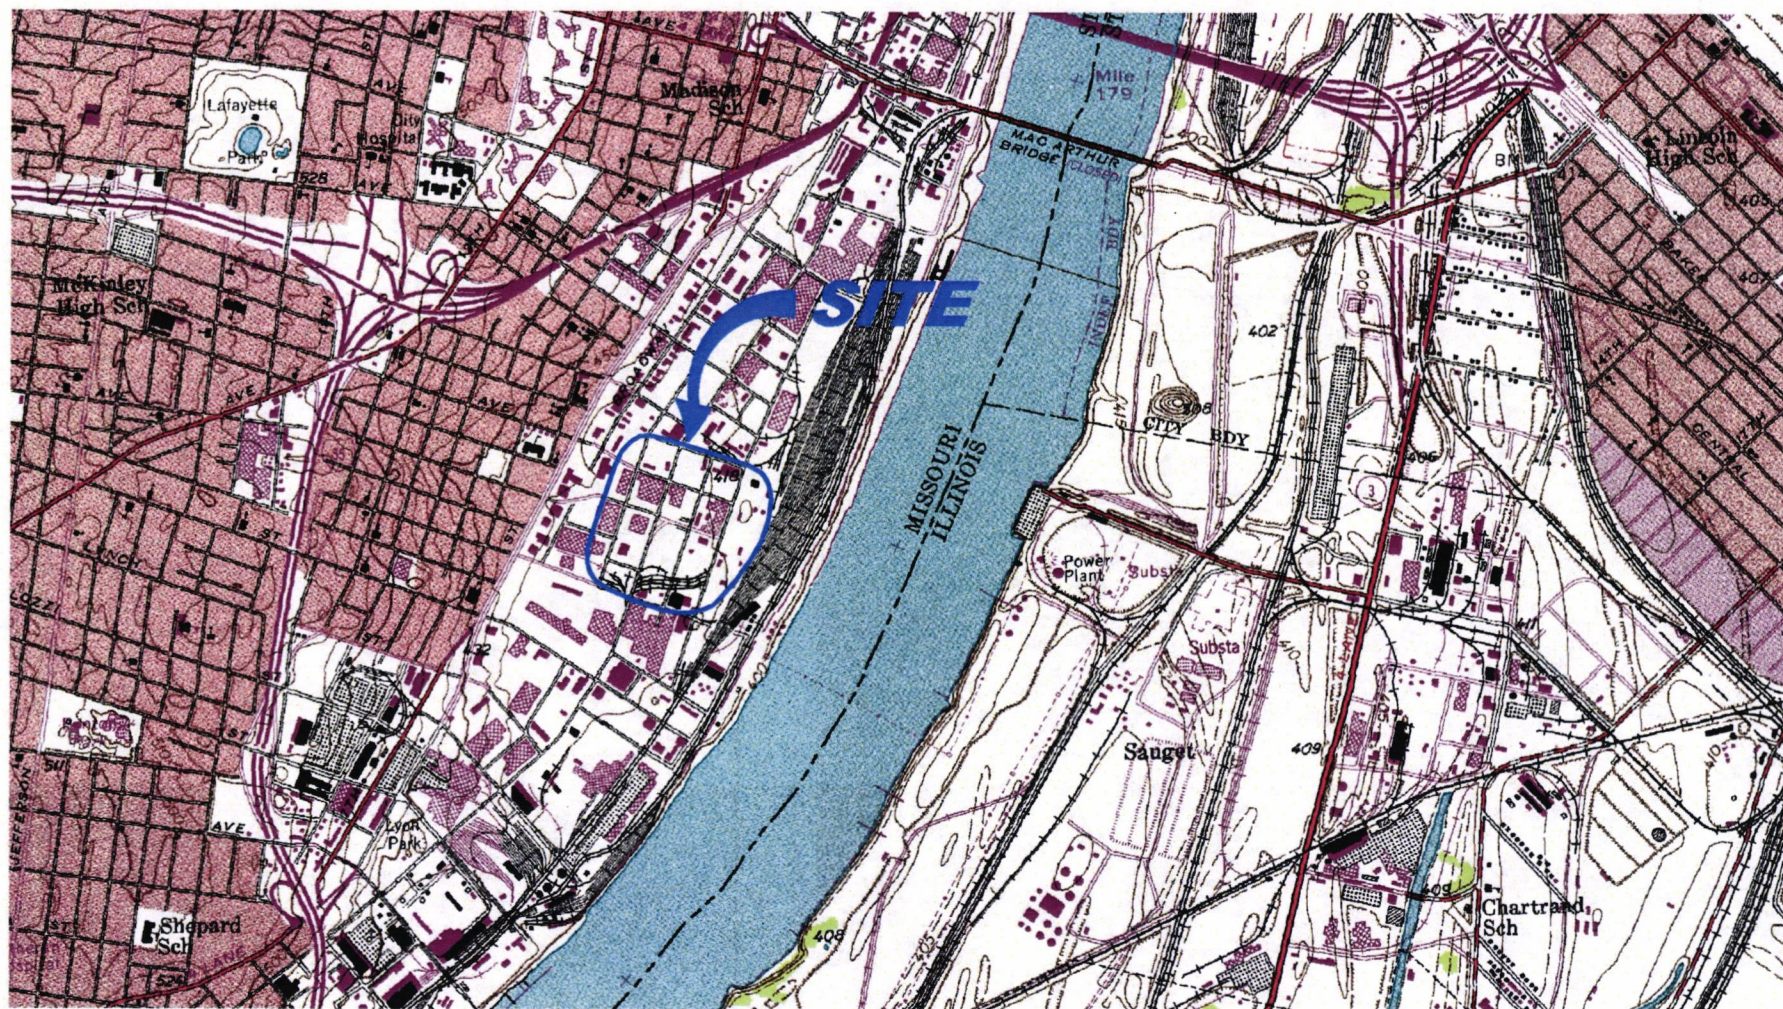
Figure 1

- GENERAL LOCATION OF
J.F. QUEENY PLANT

Site Location Map
Former Solutia Queeny Plant
Saint Louis Missouri

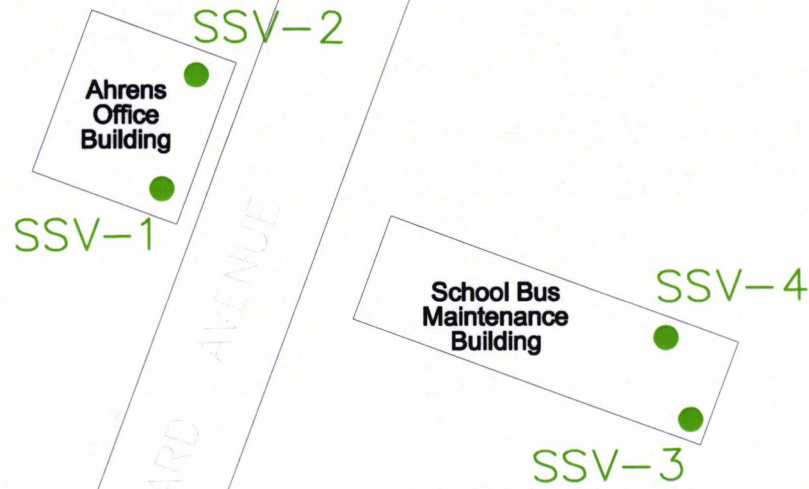
The general Solutia site location is depicted in Figure 1. Figure 2 shows the two buildings identified and described in the work plan for collecting the sub-slab samples. The figure also shows the approximate location of the samples and their designation. These buildings are on property owned by Ahrens Contracting, Inc. (Ahrens). Mr. Ted Ahrens, Jr. was contacted to facilitate access. To minimize any disruptions to regular work activities at the planned locations, at the request of Mr. Ahrens, we agreed to conduct the sub-slab vapor collection on Saturday, September 24, 2016.

- Sub-Slab Vapor Sample

**Sub-Slab Vapor
Sample Locations**
Former Solutia Queeny Plant
Saint Louis, Missouri

Collection of SSV-2 was at the eastern end of the hallway. The first three attempts to penetrate the concrete slab were each terminated after drilling nearly three feet into concrete. Upon concurrence with MDNR, the location was moved further east into a room beyond the hallway. The concrete was about 10-inches thick, as seen in the west end of the building, and a sample was collected at this location.

Sample SSV-3 was obtained from the bus maintenance building. The specific location was at the southwest corner of the break room. Sample SSV-4 was also obtained from the bus maintenance building, collected from the northeast end of the break room. The concrete slab for these two locations was about 4-inches thick.
